## **The Restoration Of The St.Francesco's Holly Monastery (Italy)**

**Olimpia Niglio**

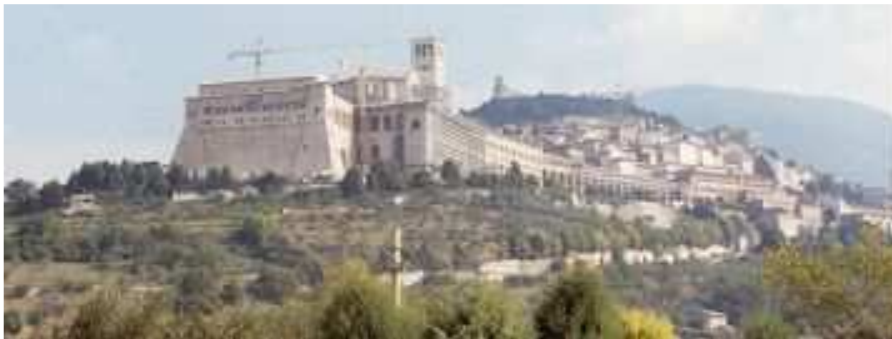
Restauro Italia is a brand that includes several companies dedicated to solving the problems inherent in the conservation of cultural items and Italian monuments. Located in the Italian region of Lucca, in the north of the country, its main activities are the restoration of monuments, improvement of civil works and the manufacture of products for the restoration of degraded structures. Among the jobs realised by the company are the restoration of facades and interiors of several churches and palaces. This article explains the process of restoration of the walls of the convent San Francisco de Asis, in the Italian city of the same name.

Following many tests carried out on the building face in the presence of professor Paolo Rocchi (University "La Sapienza" - Rome) and successive inspections executed by the works management, a methodology of intervention was decided upon after careful consideration of the state of decay.

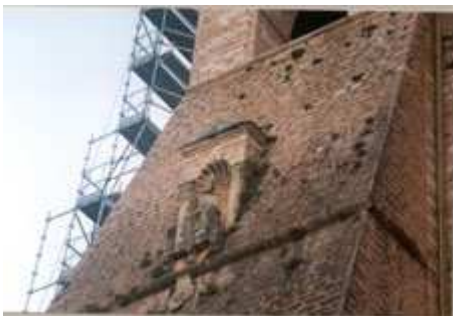
The area concerning the restoration expands approximately westwards and southwards. The building is constituted by cut stones of Assisi of medium dimensions (about 35 x 15) joined with natural hydraulic lime mortar with dimensions of about 1-3 mm. This mortar presents diffused areas of decohesion. The face develops from the ground with an inclined scarp that, at 15 cm from ground, stops with a string-course where a vertical masonry starts going up to the covering.

In past times, on the perimetrical areas of the scarp, a renewal of original stuccoing with a pigmented lime mortar was realised and subsequently painted of dark red, of doubtful origin. This operation was realised in order to obtain, at a certain distance, a greater geometrical effect of the face. At about 3/4 of its westwards height, the architectural work presents an horizontal brickwork, in some cases alternated with cut stones composed of the remaining part of the building. The stone has shades of soft pink, that could change to a light white. This is a very compact stone without neither deep enclosures nor macropores. In rare cases, there are deep inclusions of other materials such as red jaspere or crystallization of quartzite in the cut stones.

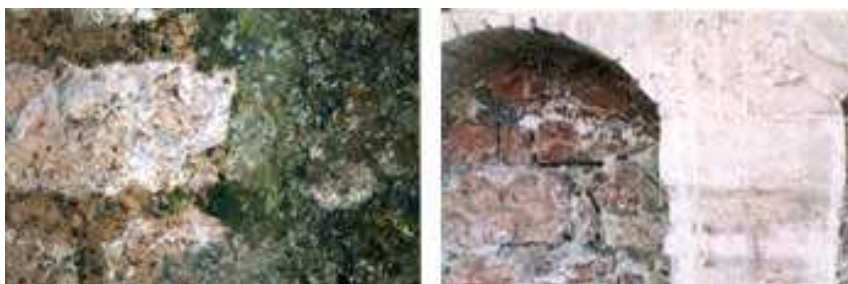
In the analysis of the three faces, there are structural settlements and lacunas of stone material: in particular, we analyse two fissures on the west side from the top to the lower part. Substantial settlements can be pointed out on the north side, for example, in the arch of the window of the scarp and other smaller fissures. On the same side and on the lower part of the west side, we can see meteoric water percolations coming out from the stones and that causes calcareous interventions on the perpetually damp walls. In the area of the face placed between the foundations and the first string-course and length of the perimeter of the building there is a uniformly strong biological attack on the stone that spreads stronger and more actively on the west and north side, and weaker (but no less widespread) on the south side.

The above said biological attack consists of moss, lichens, and in the deeper fissures of the stone consists of superior plants and wooden shrubs.

Where stones suffered a stronger attack by lichens and symbiotic microflora, the stone surface suffered a biochemical alteration, due to the soluble and disintegrating action of the nutritional apparatus of the same lichen, which interacts with the chrystalline structure of the stone and makes alterations unlike other areas of stone material with moss and algae.

On the central side of the three ornaments face, there are some areas not too narrow with presence of black crusts (oxalate of calcium). Besides, we notice some traces of color (water-green or yellow ochre) located on the underside of the arches of the ornament, set on the central side of the north side face. These chromatic traces are strongly anchored to the substrate of calcium that covers a good percentage of the internal areas of the arches and borders.

The intervention was begun with a careful photographic documentation of the areas involved by the biological attack and of the lacunas of the faces and fissures.

The superior plants were removed by mechanical means in order to extract some deep roots.

Where stronger root apparatus could endanger the stability of the stones, these were eliminated by deep drilling, assuring this way complete elimination.

In every fissure, from where plants or roots were removed, a solution of hydrogen peroxide was injected to sterilize the same hollow.

The cleaning methods we have chosen are based on the use of variable pressure water spout machine, with helicoidal jet nozzles, at tangential impact, that do not damage the stone surface at all.

Where fissures between stones are particularly deep, because of settlements of original mortar, a mortar with a basis of natural calcium was applied the granulation of which is like the original one and whose chromatic tone is lighter to emphasize the restoration.

In the areas affected by a formation of black crusts, not removable by washing, the application of compress of ARBOCEL was indispensable, with a water solution of variable percentage of ammonium carbonate.

Where the original mortar is covering the stonework, because of the precariousness of the material, we recommend a consolidation with a basis of silicates, as in the areas where the superficial layer presents original pigmentations.
